Intel[®] Mobile Celeron[™] Processor at 550 MHz, 500 MHz, 450 MHz, and 400A MHz Specification Update

Release Date: April 2000

Order Number: 245421-003

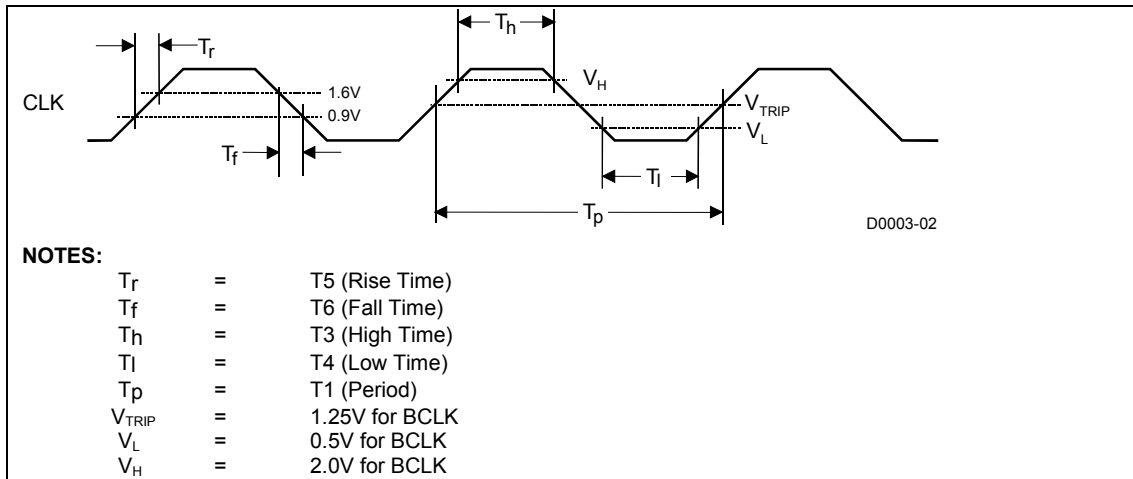
Figure 6. BCLK Timing Waveform

Symbol	Parameter	Min	Typ	Max	Unit	Figure	Notes
	System Bus Frequency		100		MHz		
T1	BCLK Period		10		ns	Figure 6	Note 2
T2	BCLK Period Stability			± 250	ps		Notes 3, 4
T3	BCLK High Time	2.70			ns	Figure 6	at >2.0V
T4	BCLK Low Time	2.45			ns	Figure 6	at <0.5V
T5	BCLK Rise Time	0.175		0.875	ns	Figure 6	(0.9V – 1.6V)
T6	BCLK Fall Time	0.175		0.875	ns	Figure 6	(1.6V – 0.9V)

1. All AC timings for GTL+ and CMOS signals are referenced to the BCLK rising edge at 1.25V. All CMOS signals are referenced at 0.75V.
2. The BCLK period allows a +0.5 ns tolerance for clock driver variation.
3. Not 100% tested. Specified by design/characterization.
4. Measured on the rising edge of adjacent BCLKs at 1.25V. The jitter present must be accounted for as a component of BCLK skew between devices.

For B0 step processors, the $V_{IH,BCLK}$ Min spec is changed to 2.0V (from 1.7V for A2 step) and $V_{IL,BCLK}$ Max spec is changed to 0.5V (from 0.7V for A2 step). Due to this, new values are specified for BCLK high and low times for B0 step processors. These modifications affect corresponding specs in Table 12, Table 13, Table 22, and Figure 6 in *Mobile Celeron™ Processor in BGA2 and Micro-PGA2 Packages at 500 MHz, 450 MHz, and 400A MHz* datasheet.

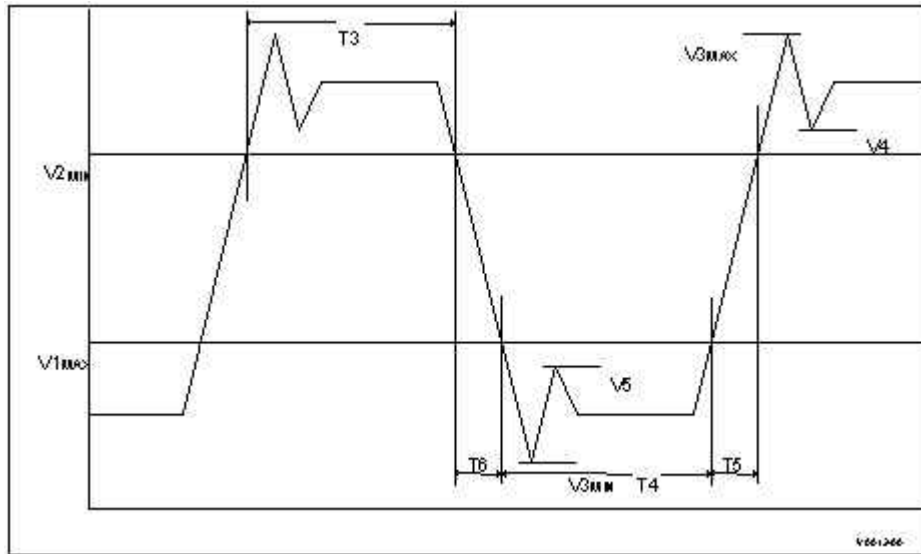
Figure 4. BCLK Waveform at the Processor Core Pins

- The rising edge ringback voltage specified is the minimum absolute voltage that the BCLK signal can dip back to after the BCLK signal passes the $V_{IH,BCLK,MIN}$ (rising) voltage limits. The falling edge ringback voltage specified is the maximum absolute voltage that the BCLK signal can dip back to after the BCLK signal passes the $V_{IL,BCLK,MAX}$ (falling) voltage limits.

In Table 18, “BCLK Signal Quality AC Specifications at the Processor Core” of the *Intel® Celeron™ Processor Mobile Module: Mobile Module Connector 2 (MMC-2) at 500 MHz and 450 MHz Datasheet*, Note 3 has changed. Figure 4 “BCLK Waveform at the Processor Core Pins” has also been updated. See below.
